MISCELLANEOUS PAPER NO. 4-789

# EVALUATION OF BUTLER AM2 LANDING MAT

February 1966

U. S. Army Engineer Waterways Experiment Station  
CORPS OF ENGINEERS  
Vicksburg, Mississippi

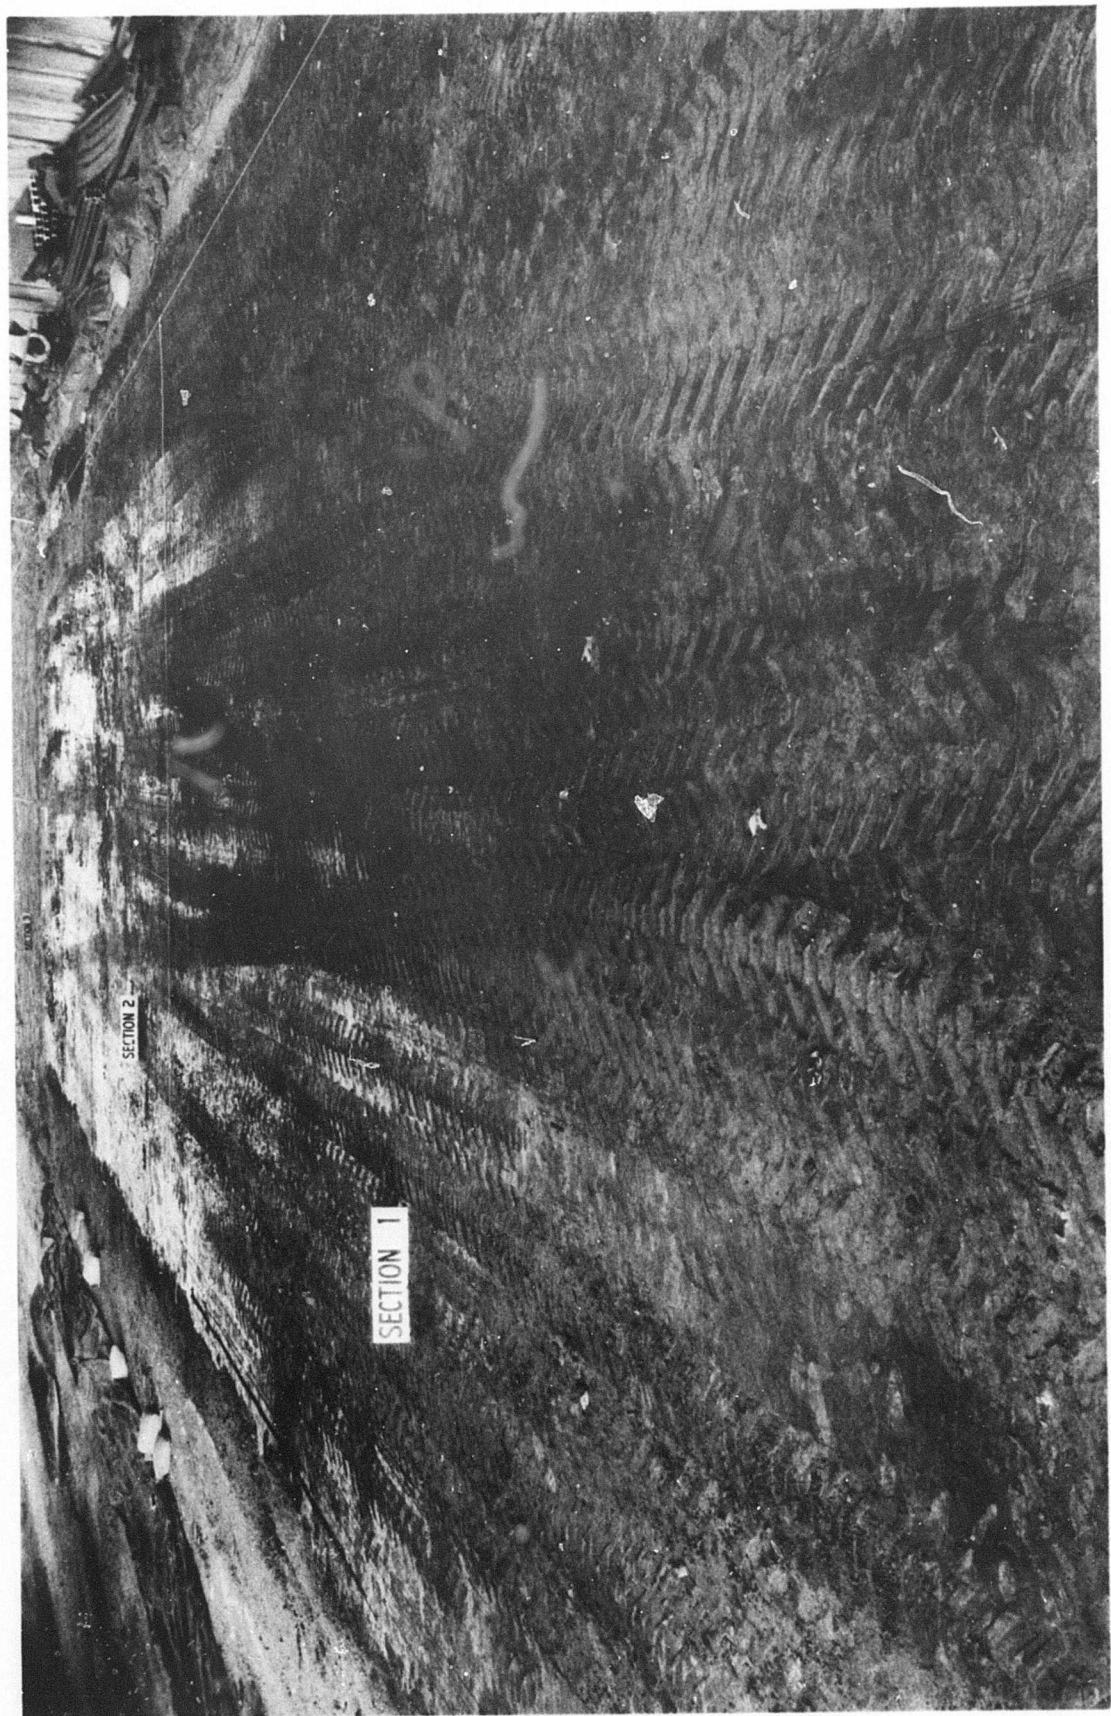
Photograph 1. Completed test section prior to mat placement

10. Item 3. Item 3 of the test section consisted of uncompacted sand 24 in. deep that had been end-dumped from a truck and spread with a D4 tractor. A CBR of about 4 was measured in the sand item prior to placement of the mat. A CBR of 4 for a loose, unconfined sand has little meaning with respect to its strength because when confined, a sand develops a much higher strength. Photograph 1 shows the completed test section prior to placement of the mat.

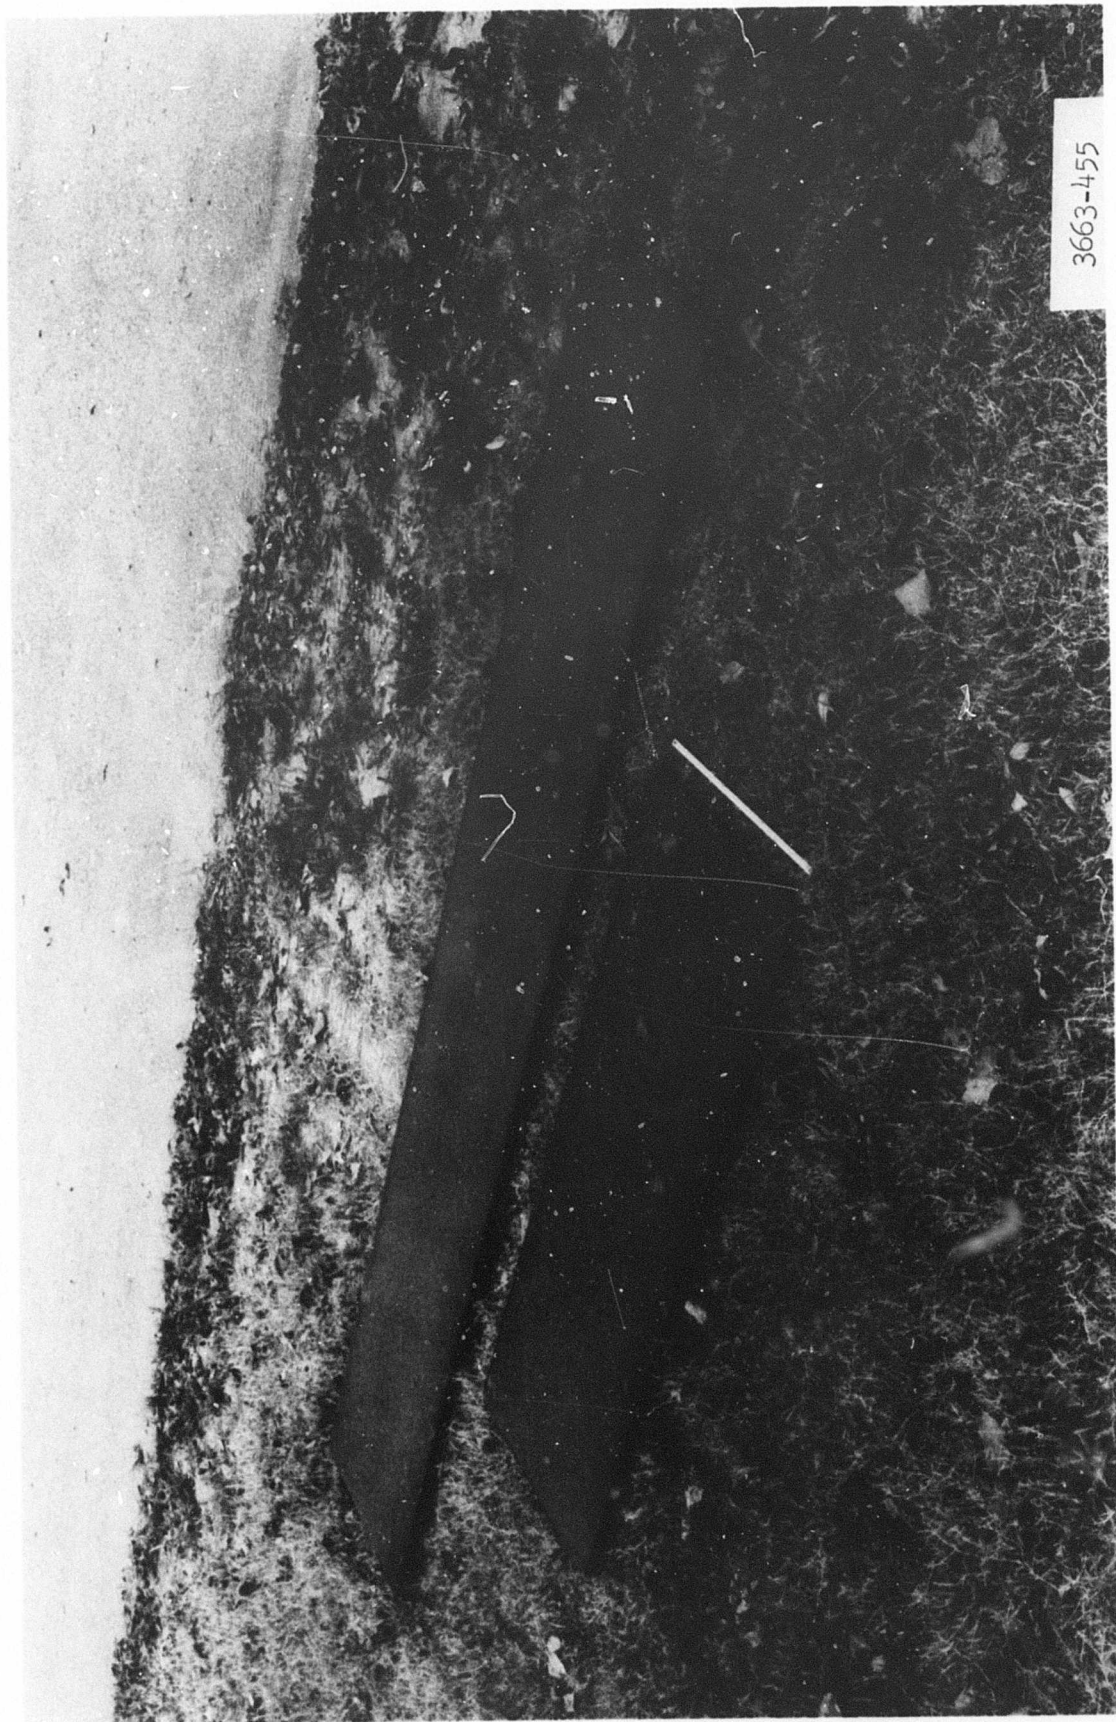
Photograph 2. Full and half panel of Butler AM2 mat with end-connecting rod

11. The Butler AM2 mat planks were made with a single extrusion. Full-size planks are 12.08 ft long and 2.06 ft wide, with average thickness of 1.50 in.; the average weight of a full plank is about 141 lb. Photograph 2 shows a full and a half plank with the end-connecting rod.

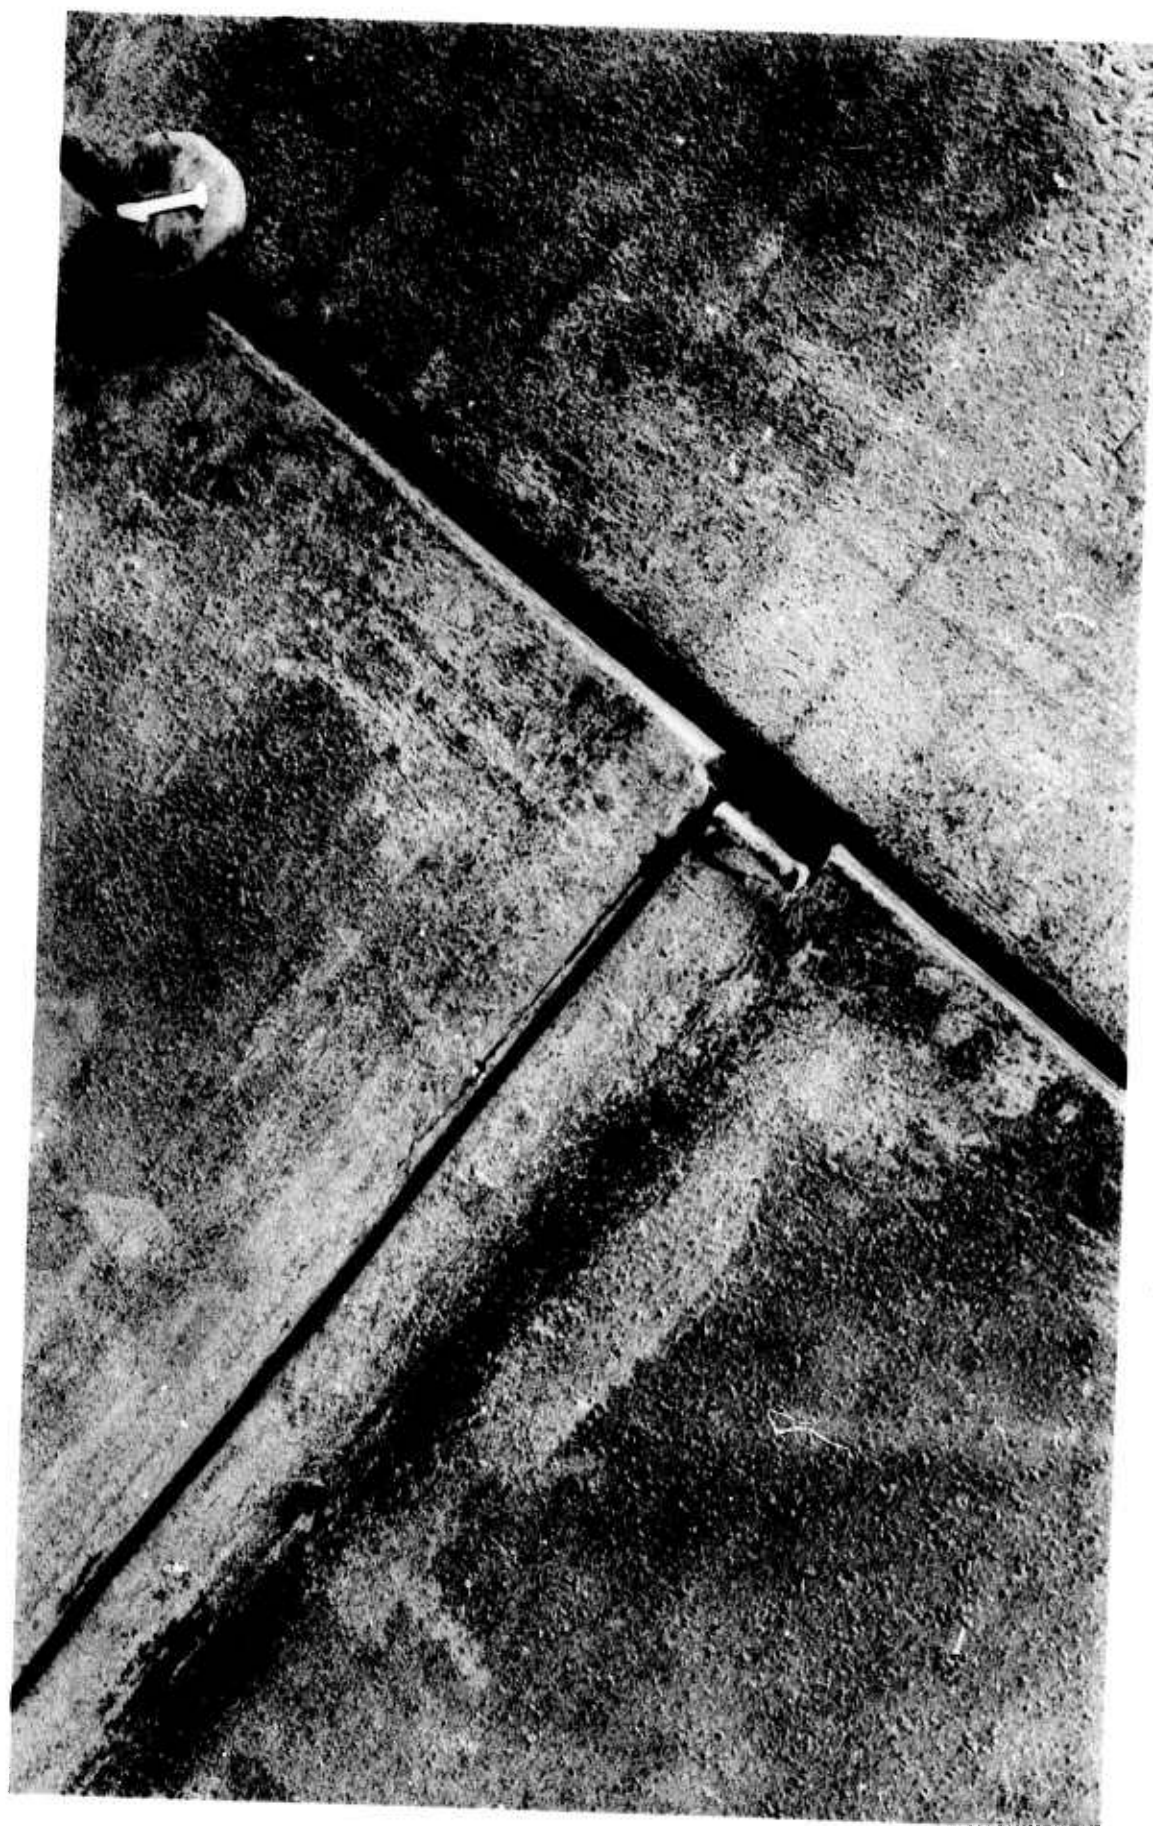
Photograph 5. Start of crack in end-joint weld

25. Mat performance. Mat breakage was first noted in item 1 after 12 coverages of traffic. The breaks were small hairline cracks between the end-connector weld and the end of the extruded portion of the plank. These breaks generally started at the overlapping edge of a plank and progressed with traffic across the full width of the plank. The first end joint sheared off completely at 36 coverages, and by the end of 50 coverages, seven end-joint failures had occurred. Photograph 5 shows the start of one of these cracks and photograph 6 shows an end joint sheared off completely. A total of 72 coverages were made on item 1. Considerable flexing of the mat was evident throughout the trafficking, although the surface remained generally smooth, as can be seen in photograph 7 which shows item 1 at the conclusion of traffic.

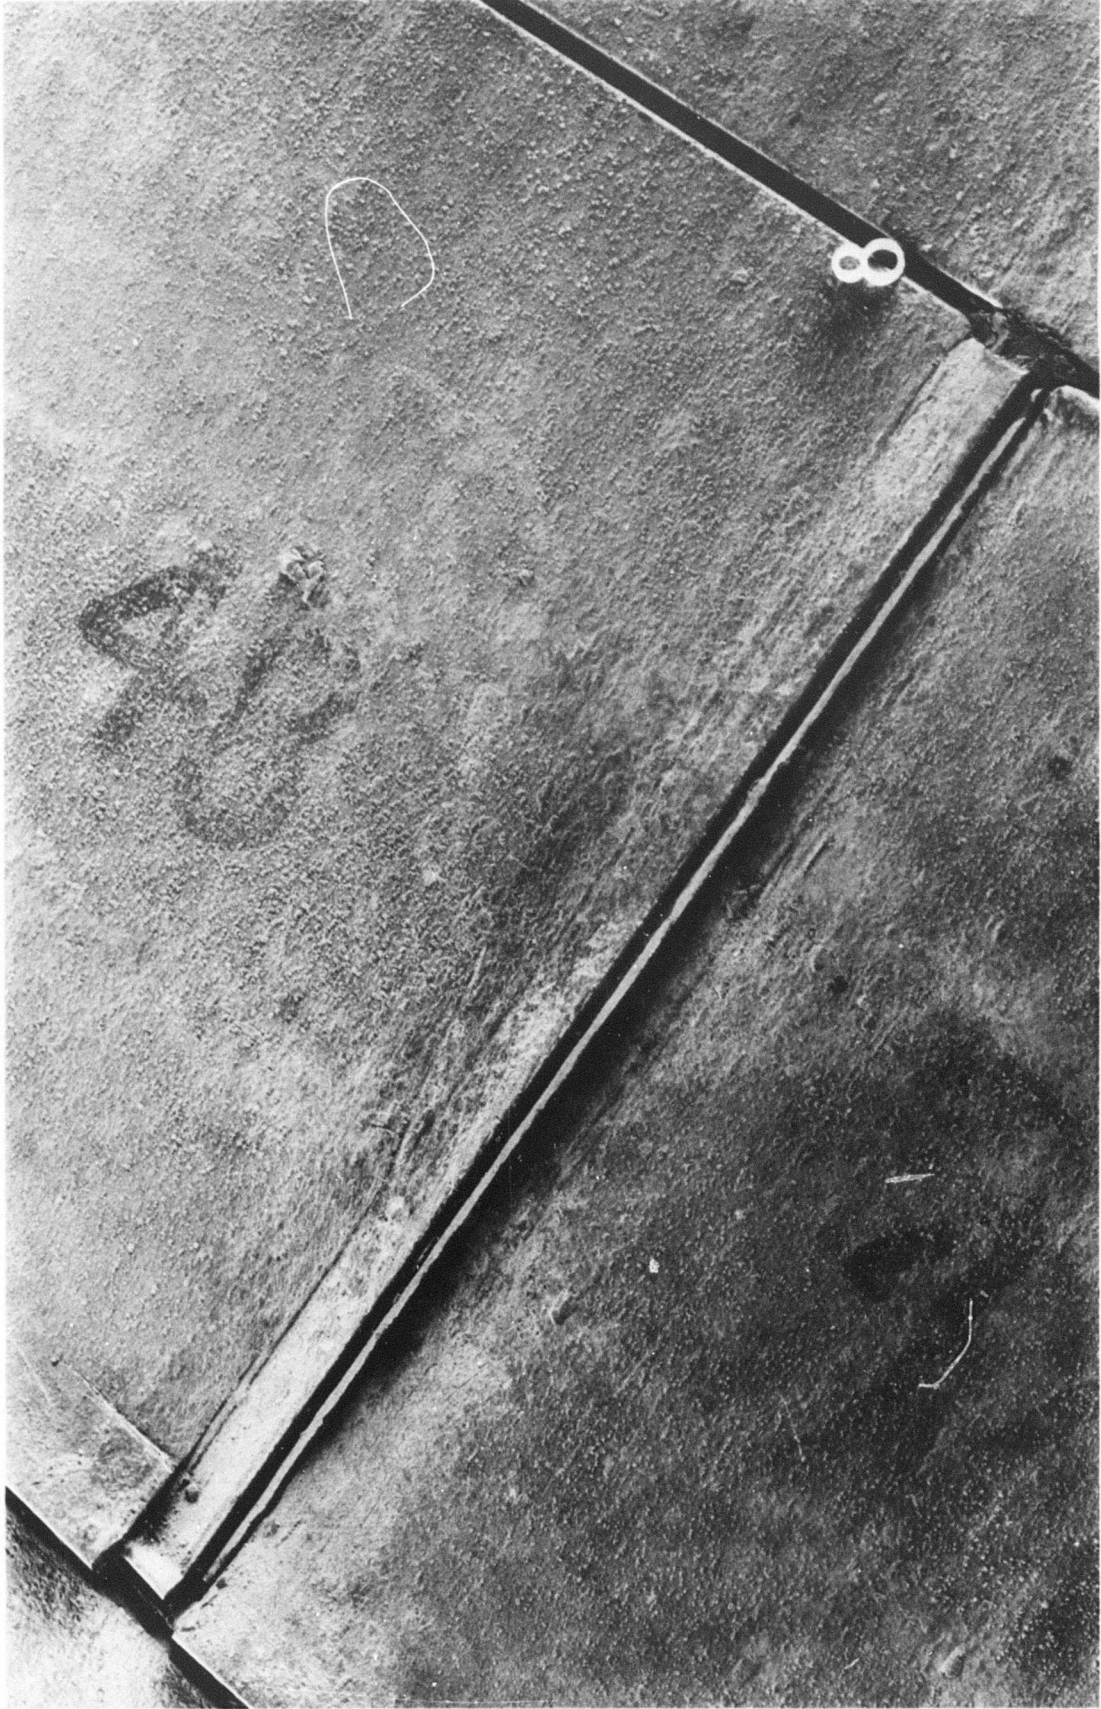
Photograph 8. Sheared end joint in item 2 after 150 coverages  
of 27,000-lb single-wheel load

26. The same progressive type end-joint failures noted in item 1 occurred in item 2. The first sheared end joint occurred at 100 coverages, and seven more of these failures were noted by the end of 120 coverages of traffic. Photograph 8 shows a sheared end joint with a small tear in the top skin at 150 coverages when traffic was stopped. Several top skin tears were noted, but their occurrence followed the failure of the end joint. A general view of item 2 after 150 coverages is seen in photograph 9. As indicated by the uneven traffic lines in photograph 9, a considerable amount of lateral shifting of the mat occurred during trafficking.
